# Prior Park Landscape Garden Signal Crayfish Project

## Report on Phase 1, 2019 - 2023

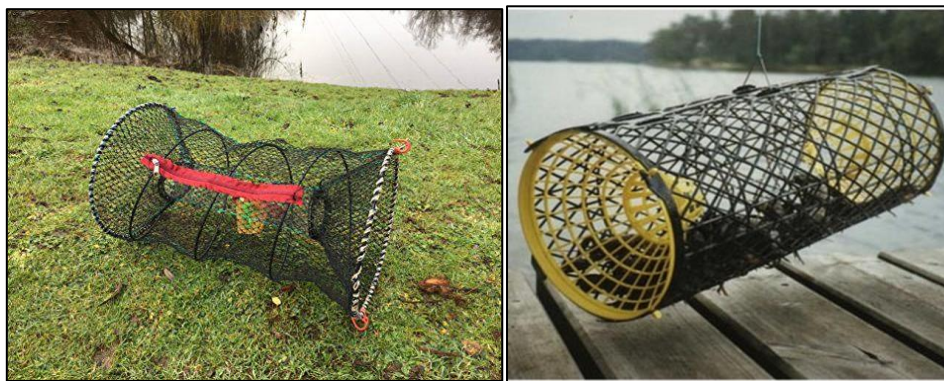
**Figure 2.** Fladen net trap (left) and Trappy trap (right)

Baited traps are the most commonly used trapping method where the crayfish are attracted into an enclosed trap using bait such as fish or cat food. They are relatively labour-intensive as they need checking every 24 hours for animal welfare reasons. Baited traps are effective in still, deep waters but are biased towards larger animals, particularly males. The project used a combination of plastic Trappy type traps and net type traps such as the 'Fladen' (Fig. 2). The smaller mesh diameter of the Fladen trap aimed to capture a wider range of size classes.

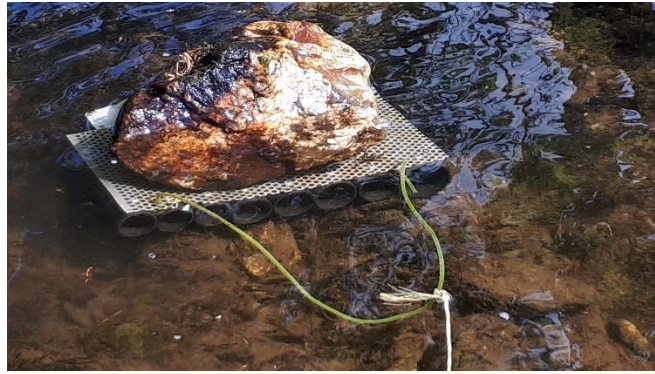
**Figure 3.** *Standard artificial refuge trap*

This trap (Fig. 3) consists of a number of plastic tubes attached to a metal base and acts as a habitat mimic. It does not require bait therefore can be left for long periods between checks. The ART is not sex biased and captures juvenile and small adult crayfish which are less likely to be captured by baited traps (Green et al. 2018). It is also effective at capturing crayfish at low densities. A 'standard' sized ART was predominantly used, with the introduction of higher capacity versions in 2022.

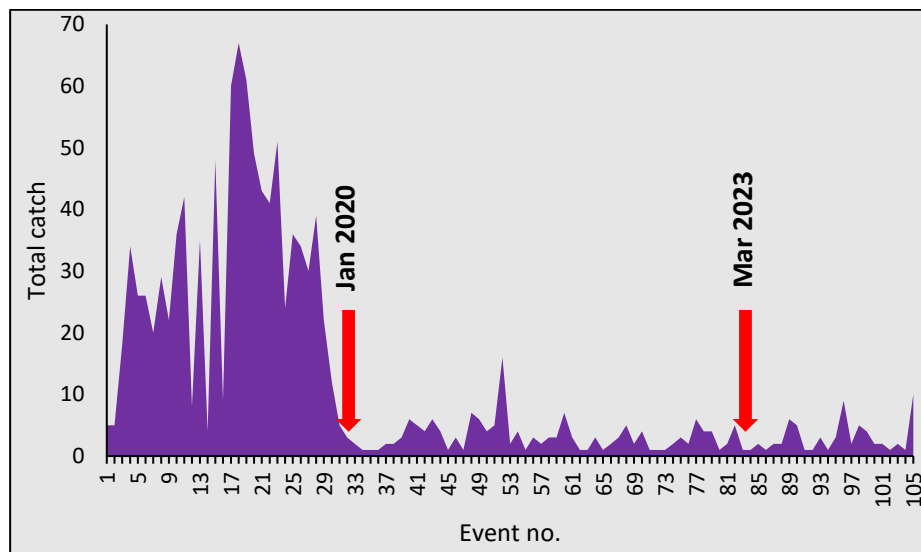
**Figure 4.** Total catch, top lake 2019 - 2023

A total of 1522 crayfish were captured and removed from the top lake over the four-year period, with 95 males being sterilised and returned and a further 158 sterilised males introduced from the lower lake between September 2019 and March 2022. Catches decreased dramatically after the fish introduction in 2020, and have remained low since that point despite most of the fish being removed in March 2023 (Fig. 4).
